Manhole Inspection Summary

Manhole # S13GG2011MH

Location Address: **2130 WESTERN RUN DR** Cross Street: **BONNIE VIEW DR**

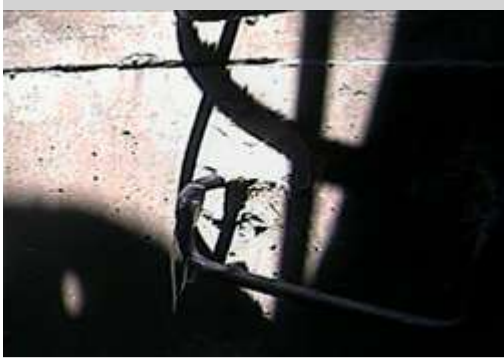
Adjustment and Corbel infiltratuion.

Evidence of surcharge

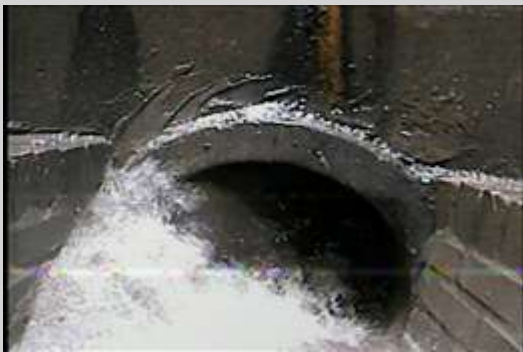
21 in. Circular Gravity Sewer Pipe Out @ 12 O'Clock

Infiltration: **None** Pipe Seal Cond: **Unknown**

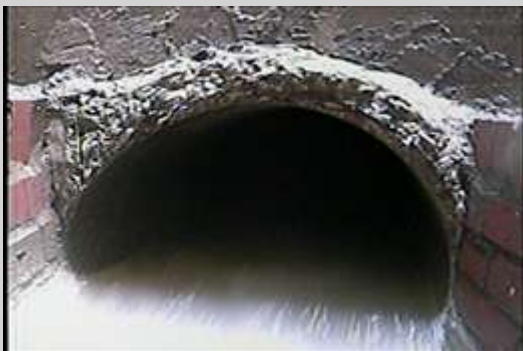
21 in. Circular Gravity Sewer Pipe In @ 6 O'Clock

Infiltration: **Evidence** Pipe Seal Cond: **Unknown**
